## **Analysis of the reasons for the crash of flight MH17 (Malaysian Boeing-777)**

### **1. The event**

### **2. Investigated questions**

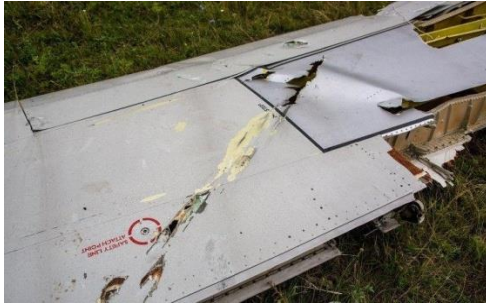
**Photo 1. A fragment from the wing of the Boeing 777**

Holes with inward edges catch the eye. These are round-shaped holes, which are normally grouped. Such holes could only have round shapes in the case of being cut with metallic elements, possibly with bars or aviation cannon projectiles. This brings up the question: by whom and how could such elements be delivered to the airplane and what could these elements actually be?

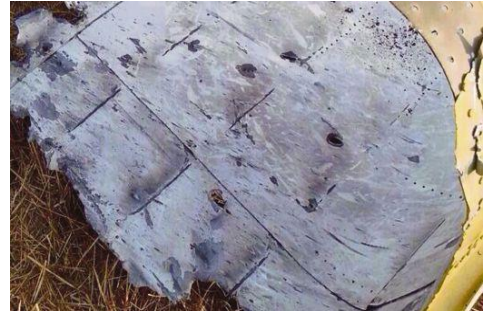
**Photo 2. A fragment from the fuselage of the Boeing 777**

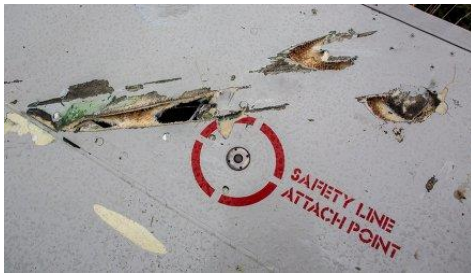
**Photo 3. A wing fragment from the aircraft**

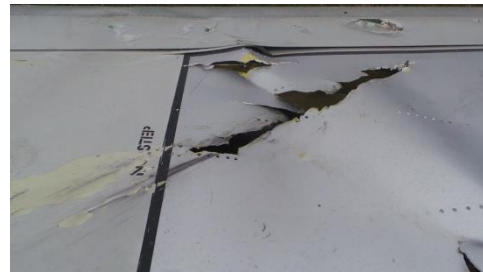
**Photo 4. A wing fragment from the aircraft**

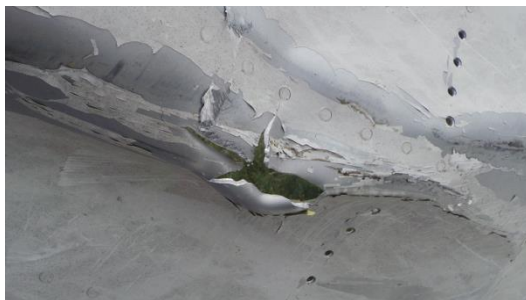
**Photo 5. A fuselage fragment from the aircraft**

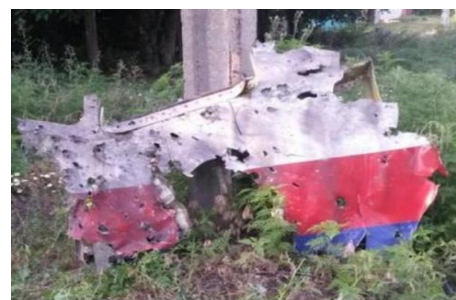
**Photo 6. A cabin fragment from the aircraft**

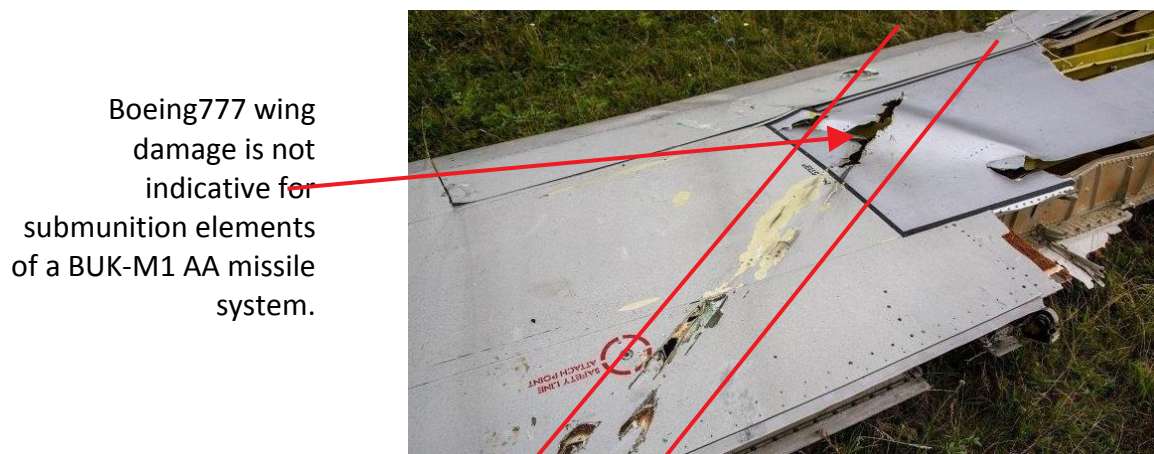
It would be more logical to assume that the damage presented in Photo 19 is more indicative for an aircraft cannon round of GSh or SPPU type.

**Photo.19. Boeing 777 wing surface damage**

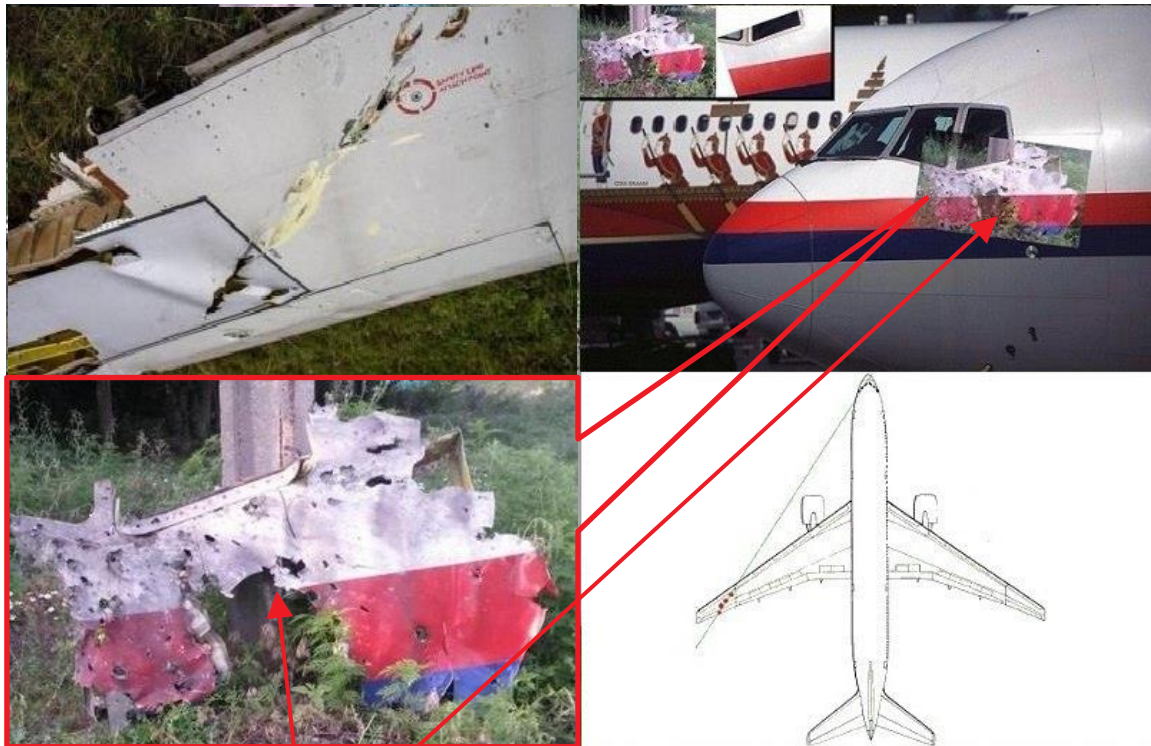
**Photo 20. Boeing 777 cabin damage**

The picture of entry and exit holes in the cockpit area (control cabin) of the Boeing 777 fully corresponds to the assumption that it was caused by being shot through by approximately 20-30mm rounds from a fighter cannon. This supports the second version of the crash. The same can be said about the nature of fragment distribution over the fuselage of the plane. From the left side the edges of fragments of the control cabin fuselage are rolled up from inside to outside, which points at significant damage inside the cabin as a result of dynamic pressure of missiles over its right side.

There are characteristic entrance holes and several exit holes visible on the fuselage. The edges of the holes are bent inwards, they are much smaller and are round-shaped. Exit holes are less precisely shaped, and their edges are bent outwards. Additionally, it is visible that the exit holes pierced the aluminum covering twice and bent it outwards. I.e., the striking elements (judging by the impact type, aircraft missile rounds) broke through the cockpit. Open rivets were also bent outwards.

The general typology of the holes and their location lead us to the conclusion that, most probably, the Boeing 777 was attacked by an aircraft cannon GSh-2-30, or an SPPU-22 container with a two-barreled 23mm cannon GSh-23L. The target zone was the control cabin, and the rounds, breaking through the cockpit, affected the wing surface as well. (see Photo. 20).

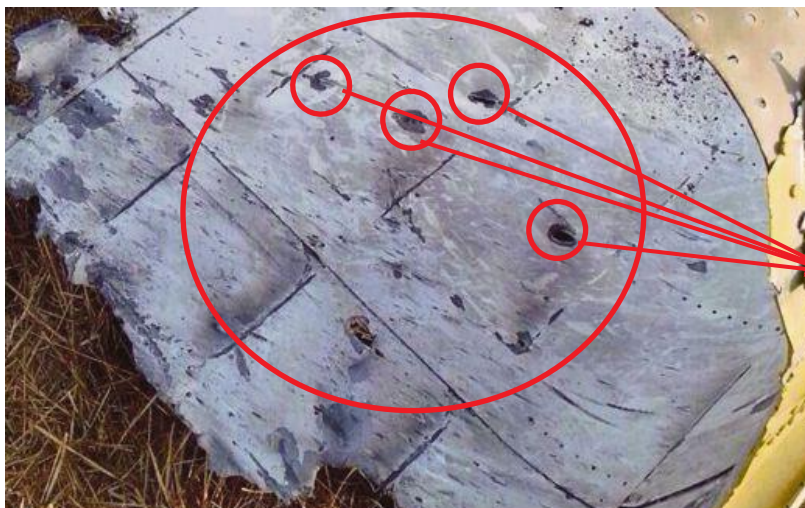
**Photo 21. Boeing 777 cover damage nature**

Boeing 777 fragment Fuselage damage is clearly visible – break through holes, caused by a 20- to 30-mm cannon.

**Distinctive inward bends of the fuselage indicate a cannon round impact.**

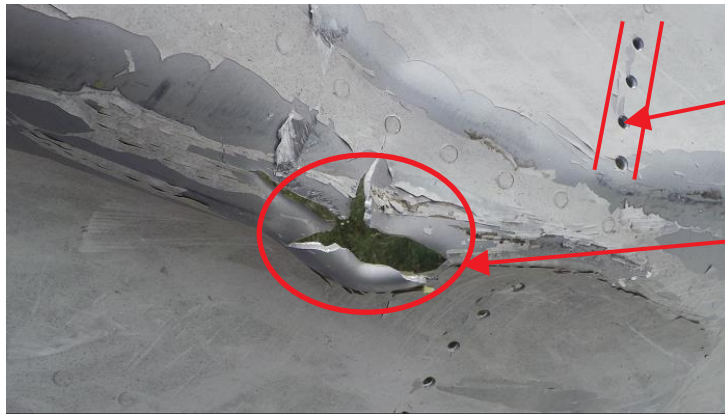
**Photo 22. Boeing 777 fuselage damage nature**

Boeing777 fragment.  
Rivets blown out.

Destruction of the fuselage with edges bent outwards due to an internal dynamic impact, either caused by an explosion inside the plane, or a sudden and rapid change of internal pressure at high altitude.
